ANNUAL REPORT FOR 2002

Cedar Point Mitigation Site
Carteret County
Project No. 6.16901T
TIP No. R-2105 AB

Prepared By:
Office of Natural Environment & Roadside Environmental Unit
North Carolina Department of Transportation
December 2002

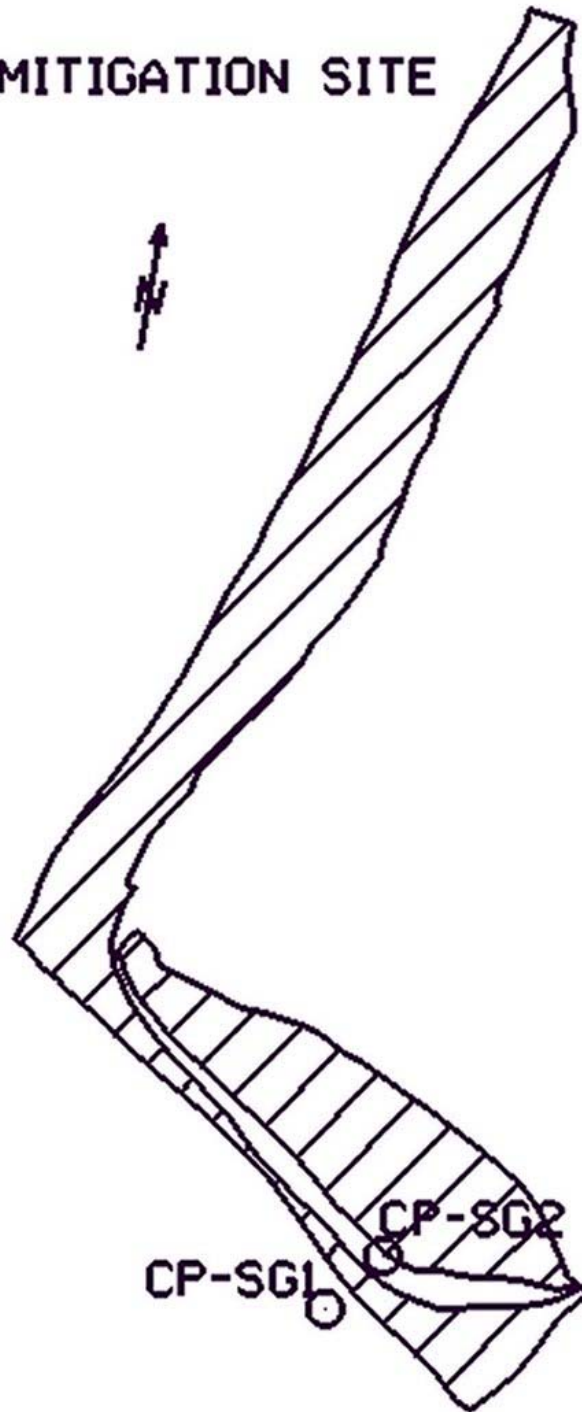
Figure 2. Gauge Location Map

Appendix A contains plots of data recorded at both of the surface gauges on the site. Both of the gauges indicate the consistent presence of surface water on the site throughout the remainder of the growing season.

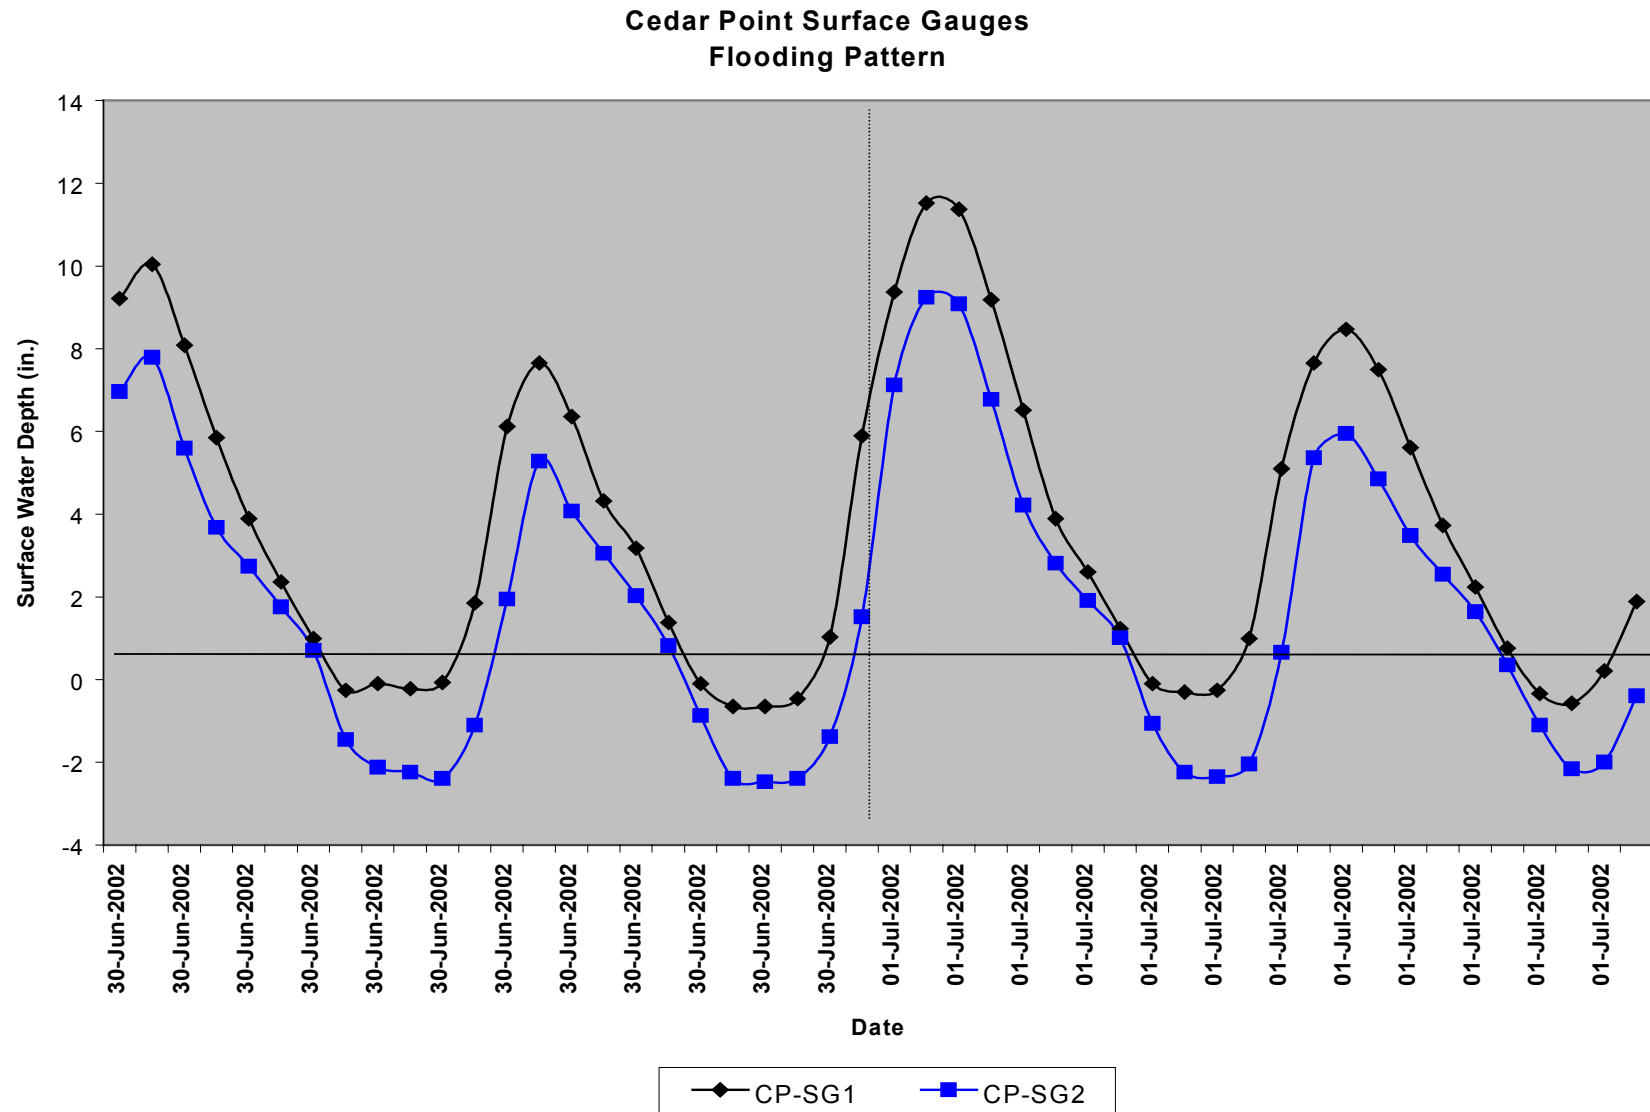
Figure 3. Plot of Daily Flooding Pattern (2-day period shown)

Figure 3 is a surface water plot of the data recorded at both gauges over a two-day period (selected at random). As the graph indicates, the site experiences flooding twice daily, as is required in the mitigation plan.

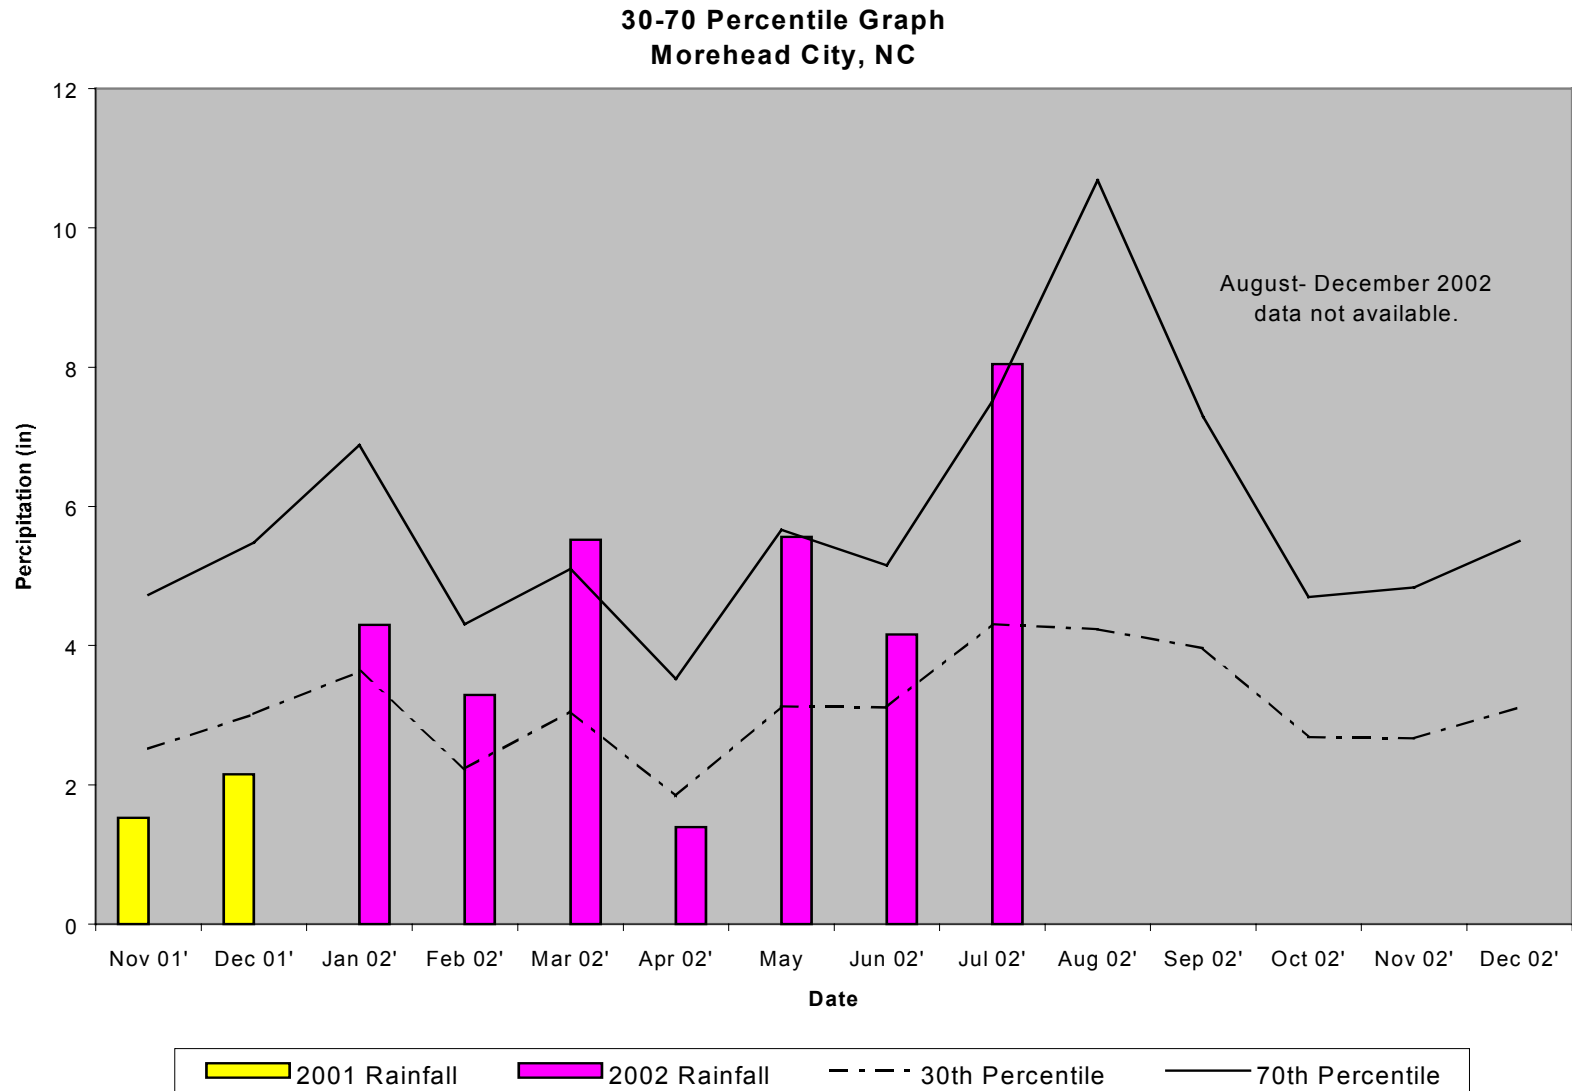
Figure 4. 30-70 Percentile Graph

The rainfall data collected at the Morehead City gauge shows rainfall totals that are slightly above average in March and July 2002. While the rest of 2002 experienced average rainfall conditions (except for April, which was below average), November and December 2001 both experienced below average rainfall. Thus for most of 2002, the site functioned within average climatic conditions. However, rainfall was never intended to be a primary hydrologic input for the site; thus it is expected that the site would show the required flooding regardless of area rainfall totals.

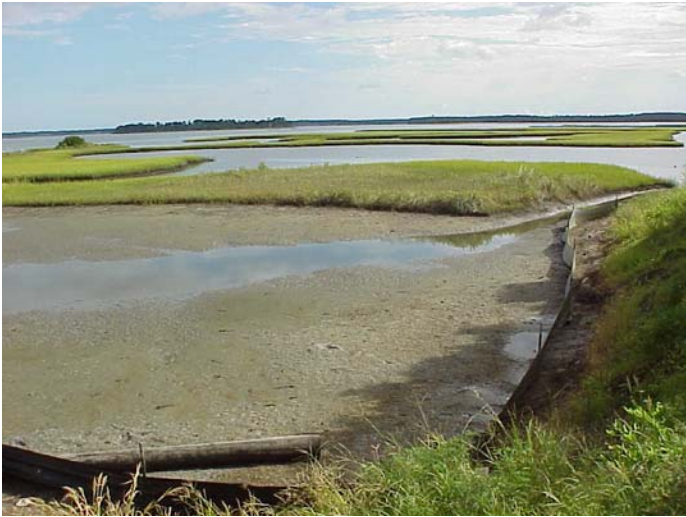
Photo 1

The site was monitored in August 2002, and minimal planted vegetation was observed. Therefore, no values were calculated for frequency and percent cover.

The Cedar Point Mitigation Site does not currently meet vegetation success criteria. NCDOT plans to gather and test soil samples and to further evaluate the vegetation failure. The site is scheduled to be replanted in 2003.
